LOW VIBRATION TRACK SYSTEM (LVT)

Track renewal – track replacement

Doc no: DPD081.GN
Rev. date: January 2011

Renewal of ballasted track under traffic

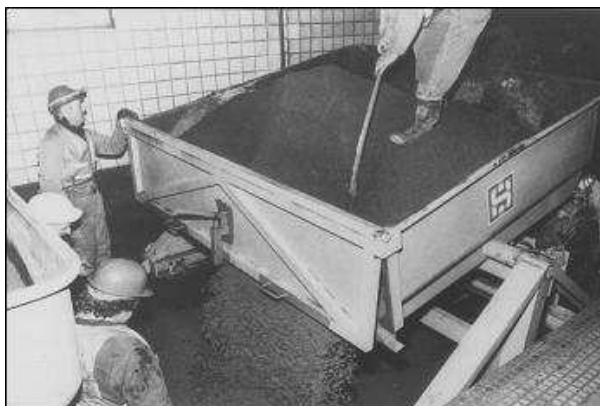
Old track removal

The first trackwork crew removed three 15-metre panels (45 m [150 ft] of track) per night, excavated the remaining ballast and placed roller compacted concrete on the foundation while restoring the drainage system.

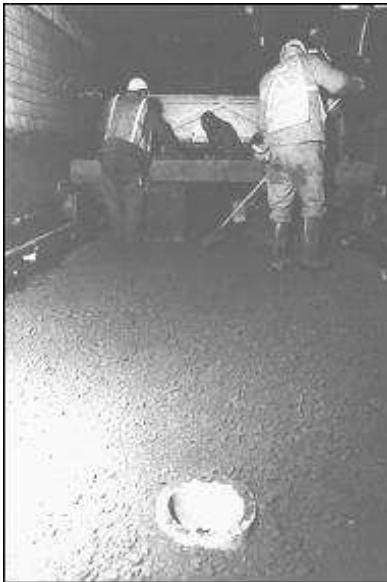
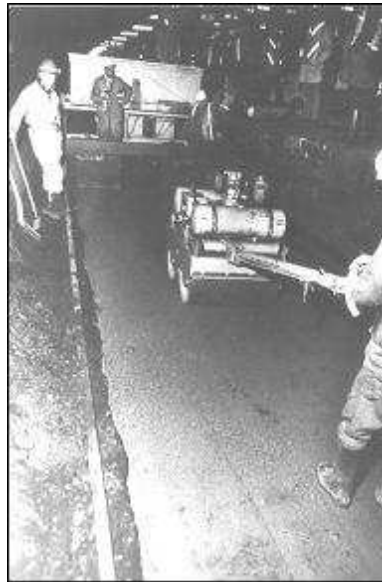
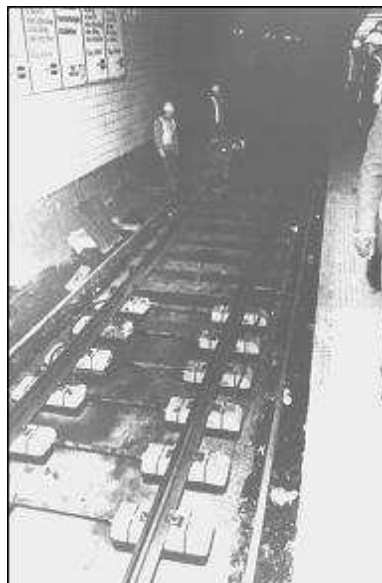
Track restoration

New track panels were then installed directly on the roller compacted concrete, the rails connected and ramps shimmed at both ends, the track temporarily resting slightly below its final level.

Traffic immediately resumed.

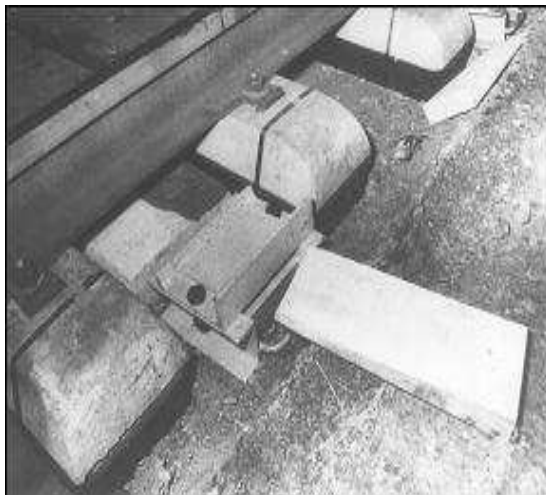
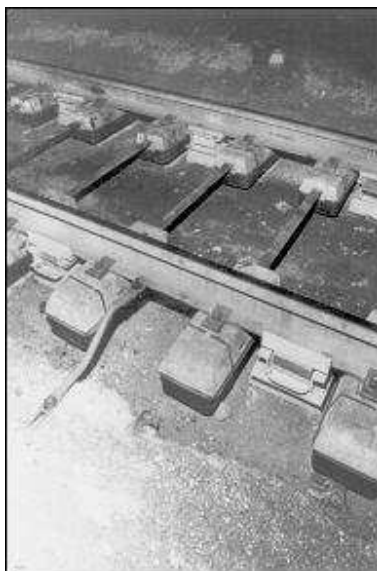
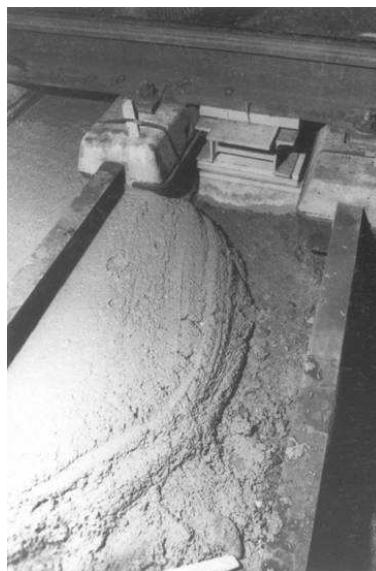
Final adjustment and concreting

The second trackwork crew adjusted the track, verified its geometry and secured it in place with shims inserted between the rail base and the now fully cured roller compacted concrete before placing and finishing the track concrete.

The loads generated by the traffic that resumed immediately thereafter were transferred directly from the rails to the roller compacted concrete through the shims without any measurable relative movement between the rubber boots and the green track concrete below.

The upper portion of the shims was later removed and recycled forwards.
